Manhole Inspection Summary

Manhole # S150O1020MH

Insp Date: **6/20/07 12:15 PM**

Location Address: **GREENSPRING AVE**

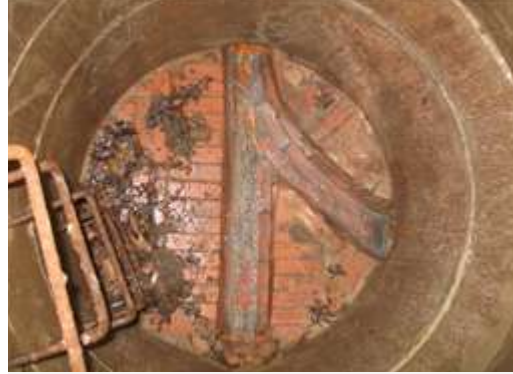
Top View

Steps Count: **5** Missing: **0** ☒ **Corroded**

Surcharge ☒ **Evidence Of Surcharge** Depth: **1** (ft.) ☐ Active Surcharge Present

Corroded steps. Evidence of surcharge - Bench debris.

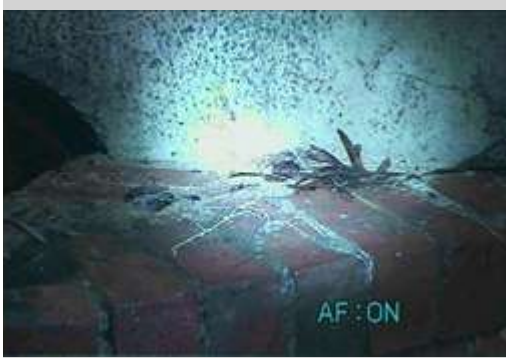
Defect

Condition: ☐ Sound ☐ Cracked ☒ **Root Intrusion** ☐ Loose Brick ☐ Deteriorated

Infiltration: ☐ None ☐ Joint ☐ Cracks ☐ Mortar ☒ **Roots** ☒ **Wall**

Barrel root intrusion.

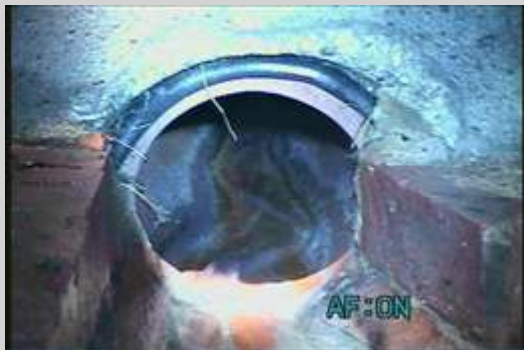
8 in. Circular Gravity Sewer
Pipe Out @ 12 O'Clock

Infiltration: **Evidence** Pipe Seal Cond: **Roots**

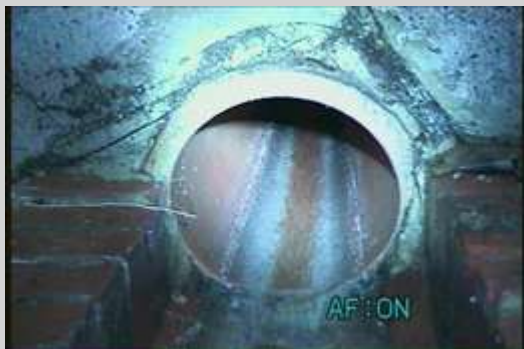
8 in. Circular Gravity Sewer
Pipe In @ 4 O'Clock

Barrel root intrusion and infiltration.

Infiltration: **Evidence** Pipe Seal Cond: **Roots**

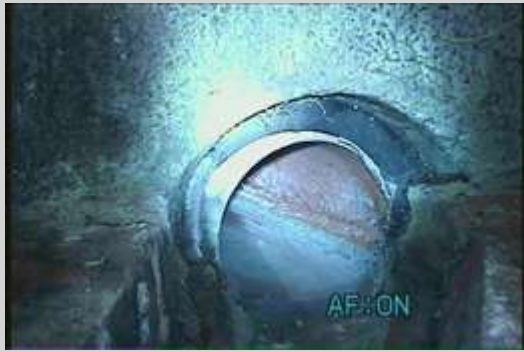
8 in. Circular Gravity Sewer

Infiltration: **Evidence** Pipe Seal Cond: **Roots**
